Secondary filtration system on DVDS and DVMX pumps

Industry:	Oil + Gas - gas extraction
Region:	Africa
Territory:	Algeria
Category:	Mechanical design upgrade
API Type:	BB1 + BB3

Ref no: CS-BB1-K-OG-01 Rev no: 002 UK

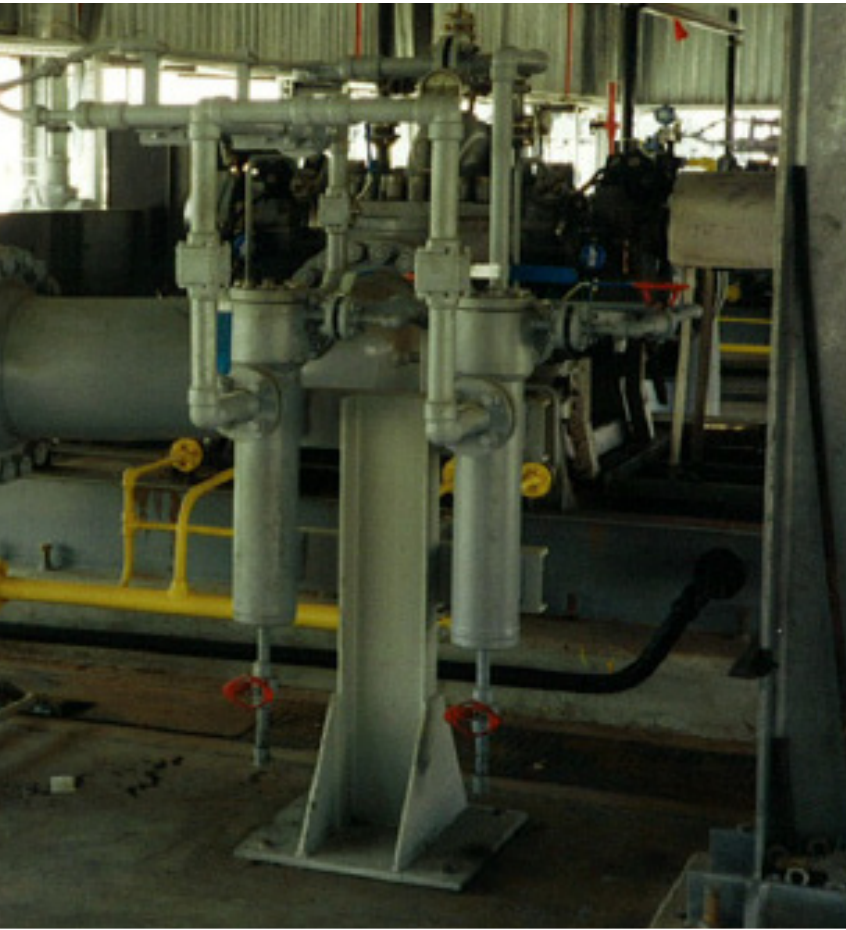
Image left: Improved filtration system for mechanical seal

The mechanical seal faces were damaged because of solid particles being present in the pumped liquefied gas, despite the presence of a filter at the pump's suction. The filtration system however was satisfactory for all other parts of the pump except the mechanical seals.

Create a secondary filtration system to remove the particles for flushing the mechanical seals. This filtration system had to be designed to allow cleaning of the filters with no interruption of the process. It also had to be certificated for an explosive atmosphere.

- Remove the former flushing pipes
- Design, manufacture and install a duplex filter system. This secondary filtration system with two filter cartridges allows cleaning of the cartridges without stopping the pump
- The fluid is taken from the pump's discharge, passes through one of the filter cartridges and then flushes the two mechanical seals
- Addition of a pressure sensor with alarm alerts when a cartridge is clogged, a valve system allows the clogged cartridge to be isolated and the fluid to flow through the other clean cartridge
- The clogged cartridge can then be removed from the filter case and cleaned
