Abrasive process upgrade for DVMX 10 stage pumps

Industry: Industrial - steel
Region: Europe
Territory: France
Category: Service centre overhaul
API Type: BB3

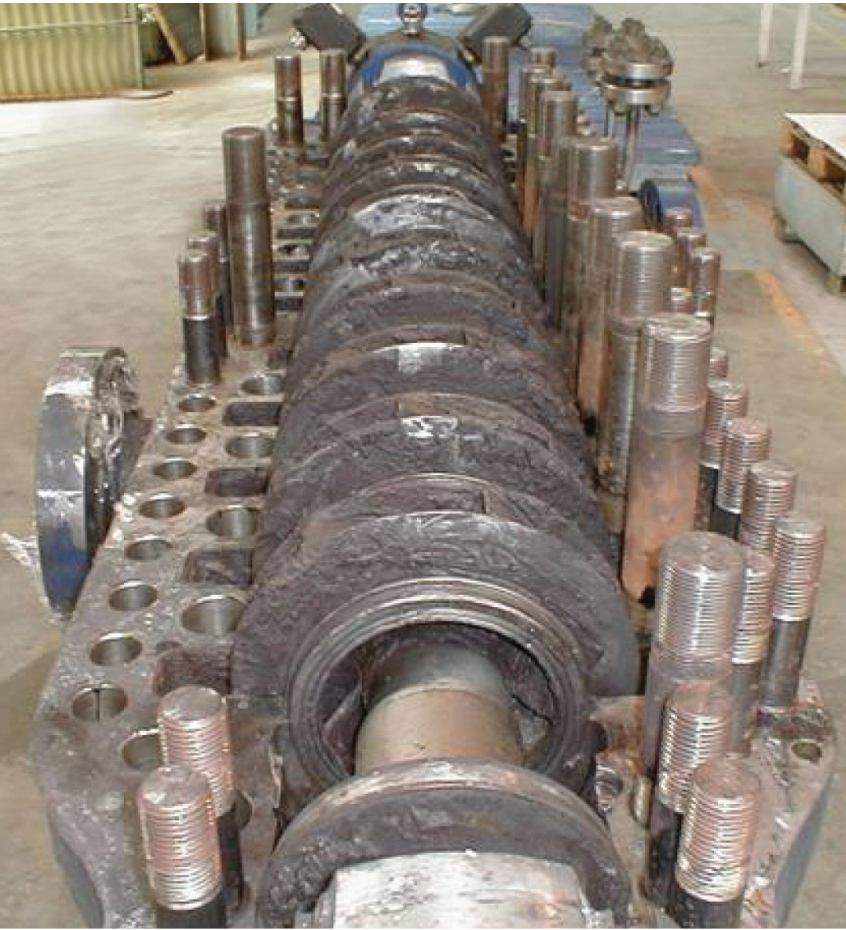
Image left: Erosion/scaling of pump parts

The function of the pumps is to water blast the scale off processed metal passing through the rolling mill. The water, containing the pulverised scale, goes to retention and decantation pools, then passes through a system of filters before being reused to blast the processed metal. Despite the system of filters, the water containing small particles of scale that is re-pumped was causing considerable damage to the inside of the DVMX pumps.

- Strip down and full dimensional inspection of parts
- Refurbishment of parts by weld deposition where possible
- Reconditioning of threaded holes
- Heat treatment and re-machining of weld repaired parts including gasket faces
- Re-boring for shaft concentricity and re-machining of gasket faces where necessary
- Cleaning of pipes and channels
- Re-assemble and hydrostatic test
- Clean down and paint

- Modifications included changes to clearances, redesign of parts and additional gaskets. The purpose of these modifications was to decrease erosion on some sensitive areas of the pumps (gasket face) and channel it to the wear parts.
- Hard tungsten-chromium carbide coatings on central bearing bush, sleeve, piston and wear rings.
- Hard tungsten carbide coatings on impellers 5 and 10 (on each side of central bearing). When the water containing small particles of scale passes between wear rings, it causes damage to the back shrouds of these impellers.

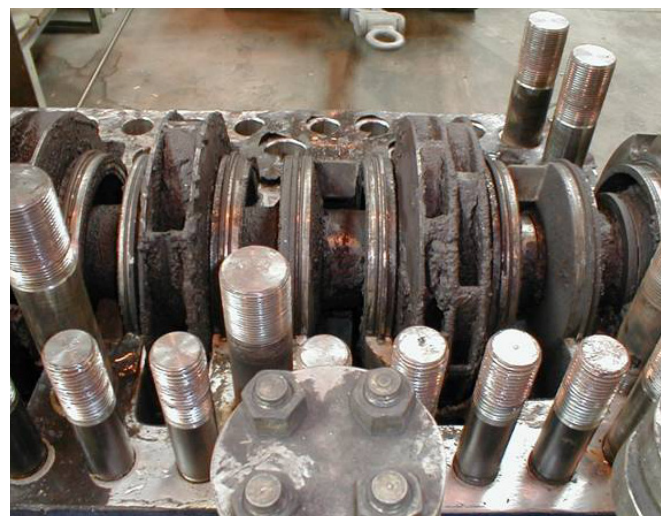
Erosion/scaling of pump parts

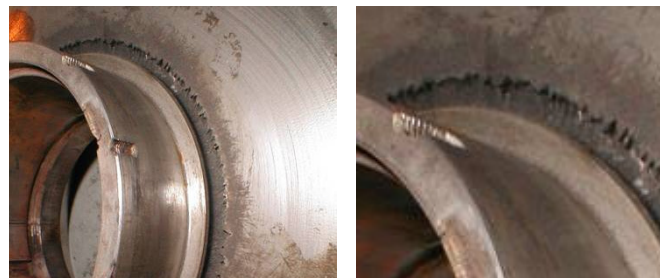
Damage to the back shrouds of impellers
