Boiler feed water conductivity

Industry:	Oil + Gas - downstream oil
Region:	Americas
Territory:	USA
Category:	Material upgrade
API Type:	OH2

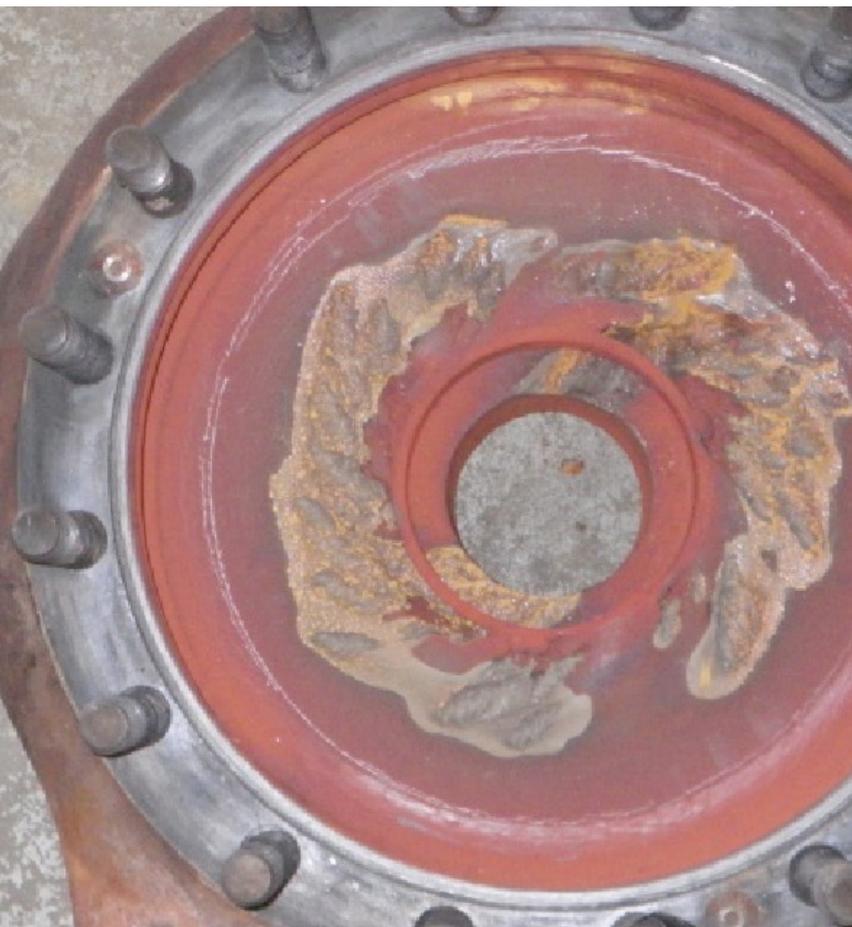
Image left: Damaged casing

A North American refinery was experiencing repeated failures of casings and casing covers on ClydeUnion Pumps CUP-OH2 pumps in boiler feed water service.

The damage was in random areas of the casing and cover, and limited to cast steel (ASTM A216-WCB) components only.

Inspection of the failed components revealed damage consistent with carbon steel in hot, low conductivity water service. The type and random nature of the damage along with service conditions are key factors in making this determination, which was later supported by an independent metallurgical examination.

This failure mechanism involves erosion and corrosion of the metal, where the protective oxide scale at the surface is dissolved, and the underlying metal is removed due to the velocity of the water.

Generally speaking, carbon steel casings must be avoided in boiler feed applications where the water temperature is greater than 200 °F, and the conductivity of the water is less than 20 µmohs/cm. In these cases, damage will occur primarily in high velocity areas. In addition, the presence of oxygen while not desirable in boiler feed water services can provide some corrosion resistance. Typically this is not an option.

- An overlay can be applied to provide a more noble material to be in contact with the low conductivity water in high velocity areas. Typically Inconel products are recommended. This option is more cost effective on CUP-BB3 type pumps in areas where stationary wear parts mount in the casing.
- The second option, which was recommended in this case, is to replace the carbon steel components with 12% chrome (CA-6NM), 316 stainless, and 400 series stainless steels (CA-6NM and CA-15) are not affected by this failure mechanism.

Replacement casing and casing covers were provided in upgraded materials with no additional reported failures.

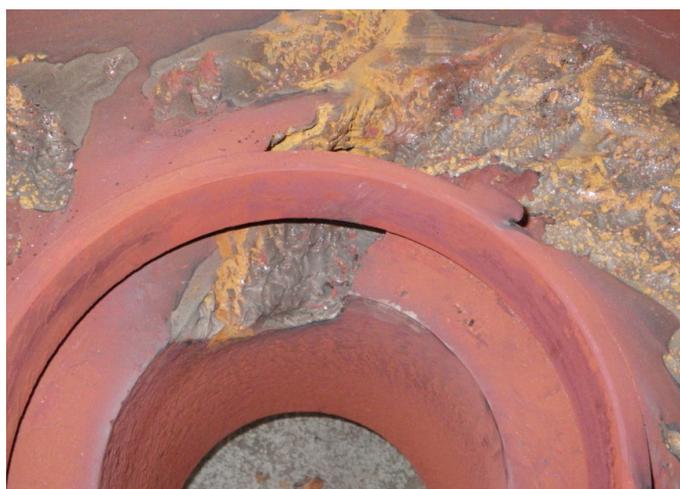
Close-up view of wear ring area
