CASE STUDY CUP-BB3 MULTI-STAGE SPLIT CASE PUMP OVERHAUL

Overhaul of DVMX for diethyl amine pumping process

Industry:	Oil + Gas - petrochemical
Region:	Europe
Territory:	France
Category:	Service centre overhaul
API Type:	BB3

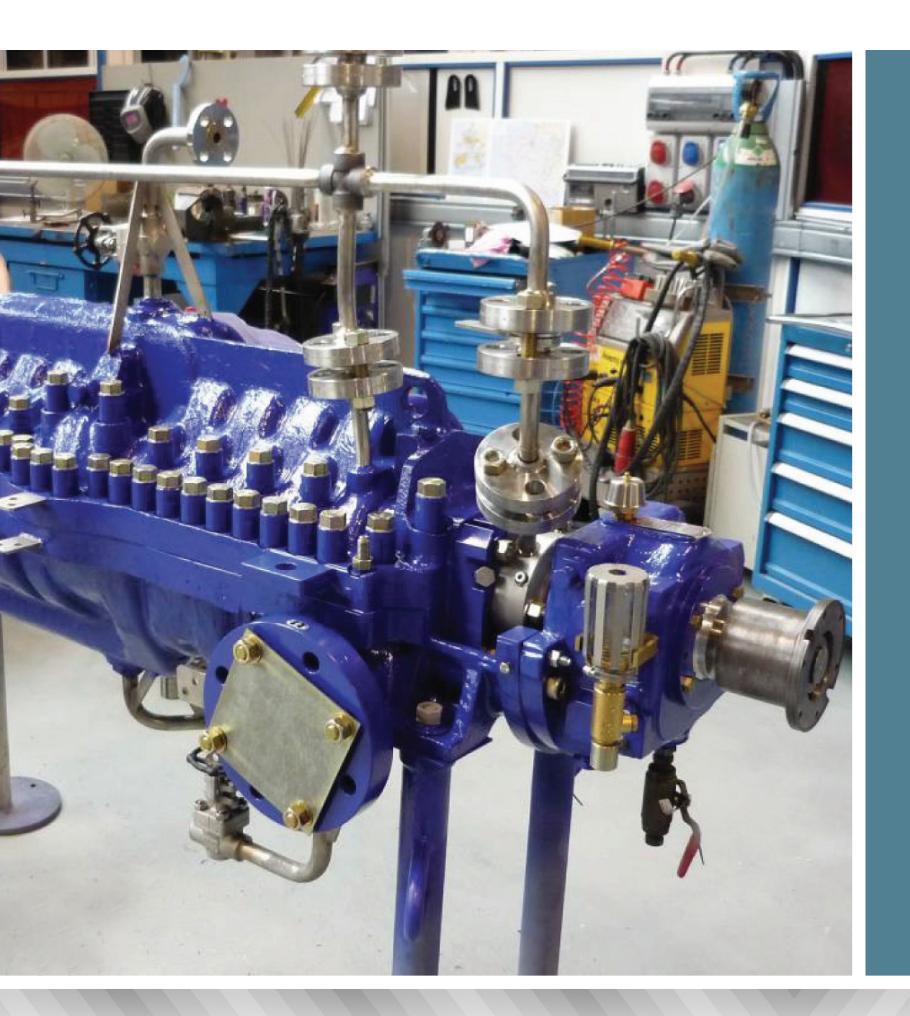
Image left: DVMX 3.4.9 10 stages pump after repair

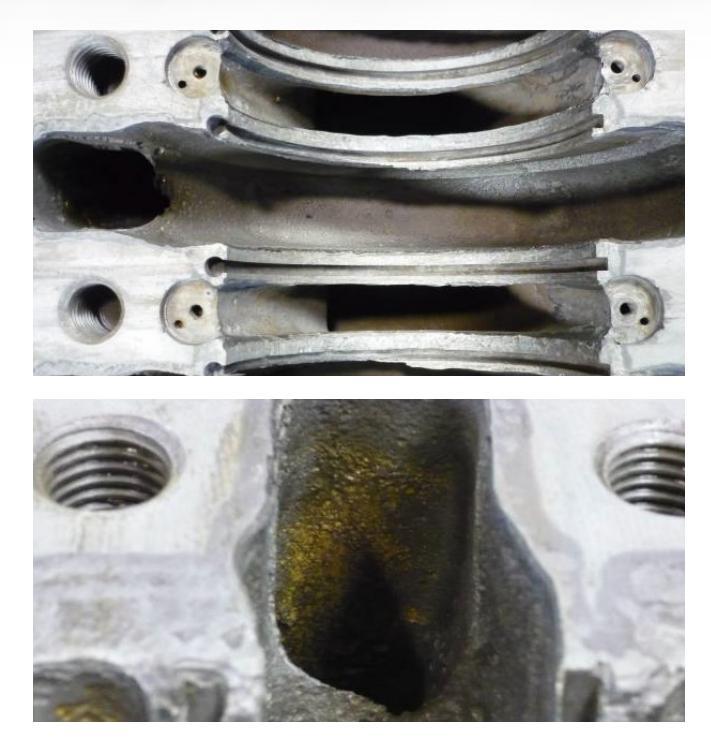
Pump casing

The DEA processes are very aggressive towards steel materials, only a few metallurgies are able to resist more or less to corrosion induced by DEA pumping. The pump was sent back to the factory without the rotor, all rotor parts were too damaged to be repaired. The pump casing showed high erosion/corrosion marks, leading to loss of material particularly on grooves for casing wear rings and volute tongues.

The solution was to carry out weld repair on all the damaged parts of the pump casing and supply of a new rotor. The difficulties were the accessibility of certain parts and the perfect control of intensity and temperature during the welding. A non-controlled welding can lead to a change in metal properties, and stress and strain on the casing.

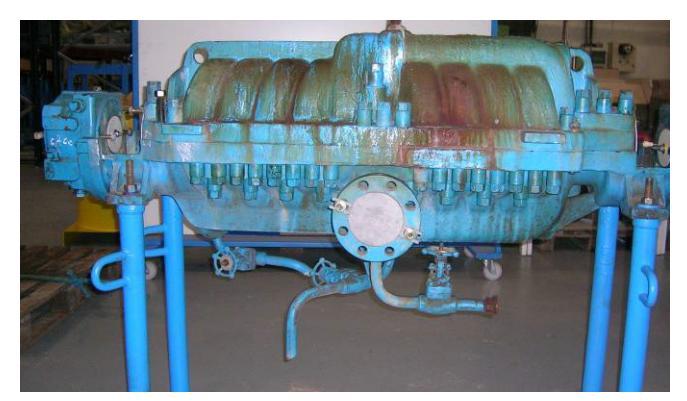
Figure 4: DVMX 3.4.9 10 stages pump before repair
