CASE STUDY CUP-OH2 BACK PULL OUT REDUCES FAILURES

Back Pull Out reduces failures

ndustry:	Oil + Gas - downstrean
egion:	Americas
erritory:	USA
ategory:	Service centre overhau
PI Type:	OH2

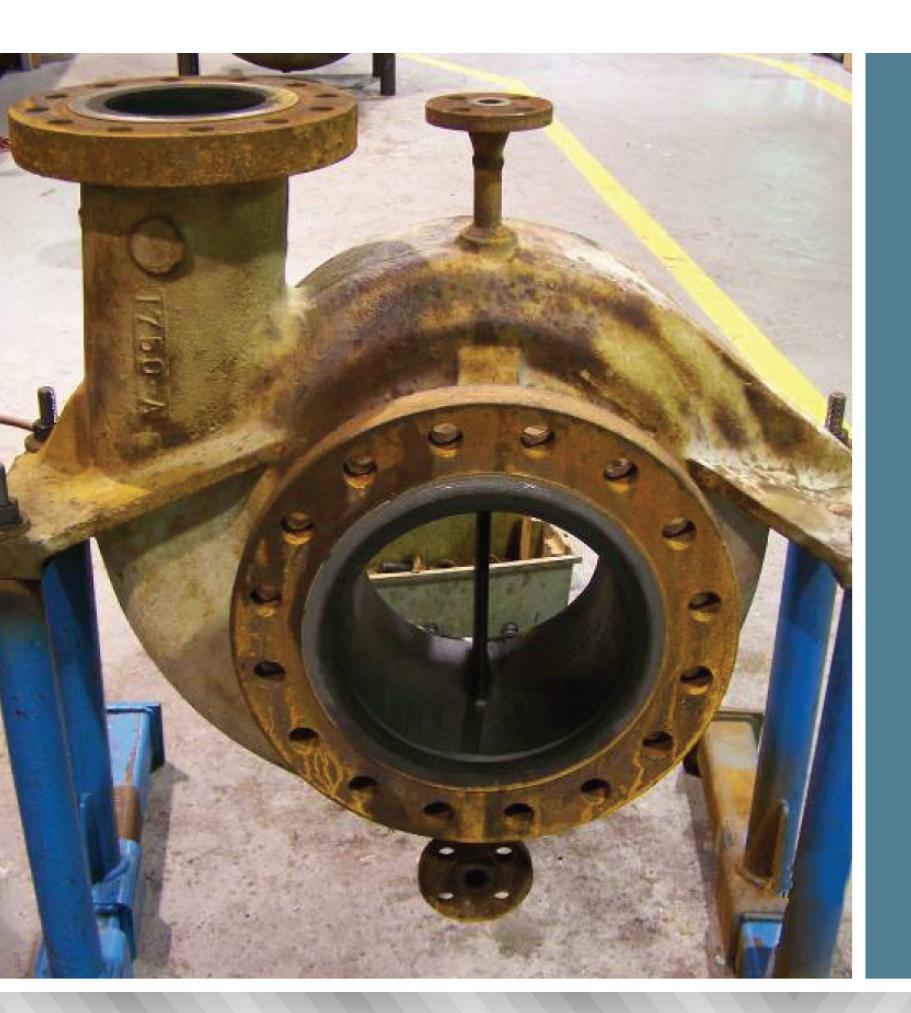
Image left: Existing casing

Reliability issues with the existing pump prompted the customer to request pricing for a 10th edition Back Pull Out assembly. In addition, the performance of the pump had deteriorated over the years due to wash-out in the volute areas of the casing.

- Damage to volute tips was undercut, weld repaired and hand dressed.
- The suction and discharge flange faces were weld repaired, along with the case ring and register fits.
- The casing was stress relieved after welding, and the casing was finish machined and hydrostatically tested.

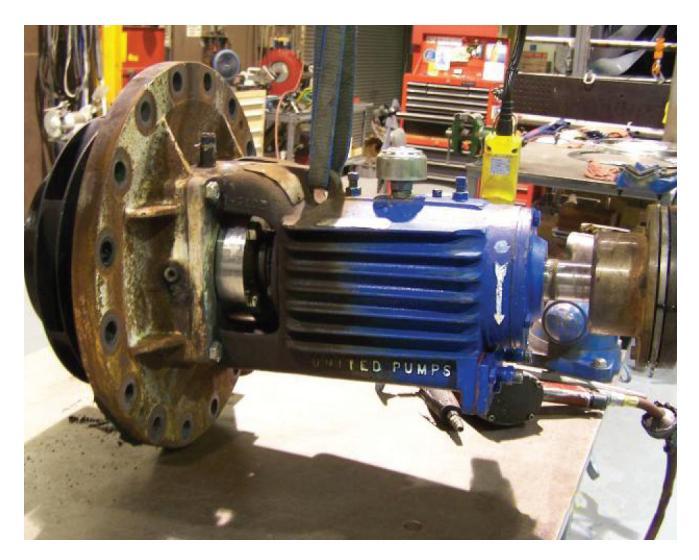
Existing bearing housing and cast cover

In addition to repair of the casing, an API 610 10th edition Back Pull Out assembly was fitted to the existing casing and impeller. A new bill of material was generated, such that all future spare parts can be provided to the customer. The pump was provided with a complete data package, and was installed on the existing baseplate without modification.

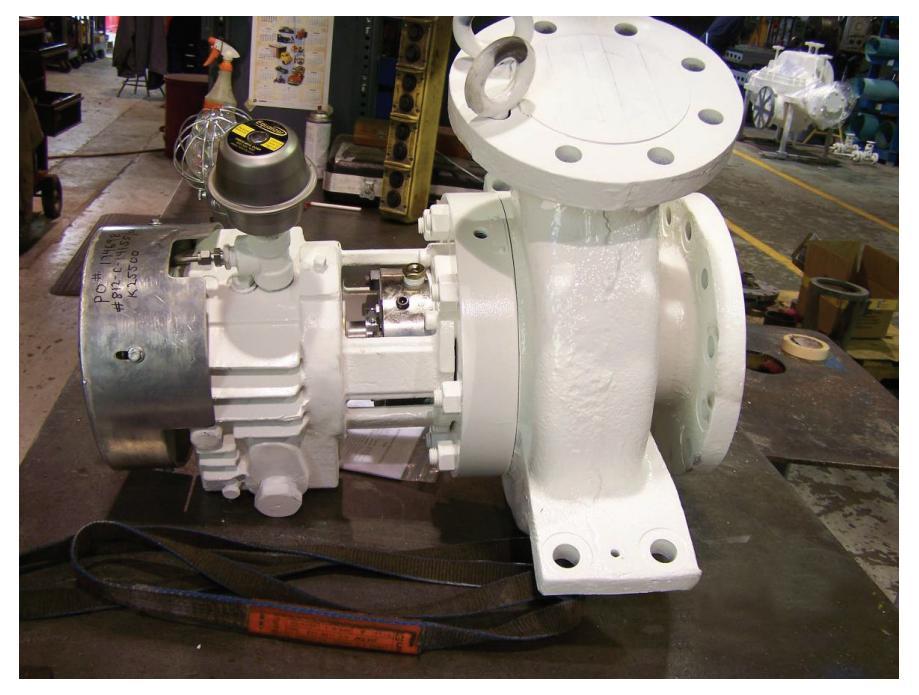
Completed pump

- Upon completion of the casing repair work, the Back Pull Out assembly was fitted. The completed pump was painted and prepared for shipment back to the customer's site.
- Since initial installation and start-up, the pump has operated well with no failures to date.
