CASE STUDY

PUMP REDESIGN IMPROVES CORROSION RESISTANCE AND REDUCES DOWNTIME

Industry: Industrial – desalination

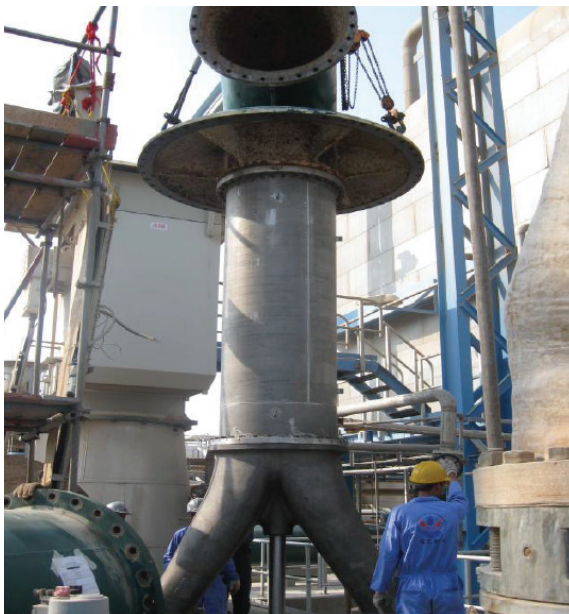
New casing being installed

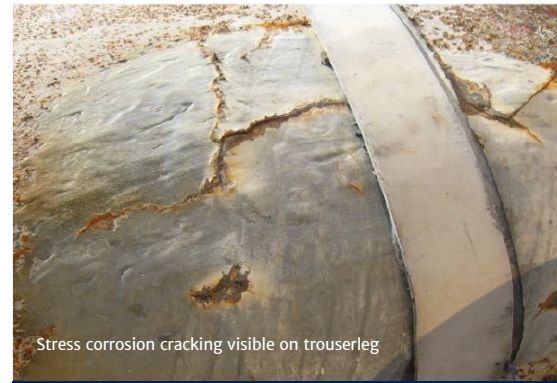
ClydeUnion Pumps undertook a design review to determine where improvements to the existing pump design could be made. They used advanced 3D modelling and rapid pattern manufacturing techniques to redesign the trouser leg, as well as upgrading the material specification to cope with the harsh operating conditions at the desalination plant. The new three-part pump casing is made from Duplex stainless steel, renowned for its corrosion resistance. The redesign also uses an advanced composite material (Tufnol) between new and existing components with galvanic potential.

The use of advanced modelling and manufacturing techniques delivered significant time savings during the repair. Pattern manufacturing time was halved, with patterns completed six weeks ahead of the original schedule. Casting thickness was reduced by 20 per cent, saving on raw materials, and a net weight reduction of 10 per cent was achieved over the original design. The new three-piece pump casing offers the opportunity for future savings because the customer can be supplied with an individual section as required, instead of replacing the entire casing.

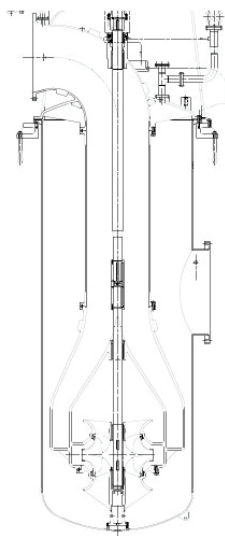
Old Pump Design

A desalination plant in the Middle East was experiencing high levels of corrosion on one of its pumps. Stress corrosion cracking was clearly visible in the steel 'trouser leg' casing. The operator asked ClydeUnion Pumps, a Celeros Flow Technology brand, to come up with a solution.

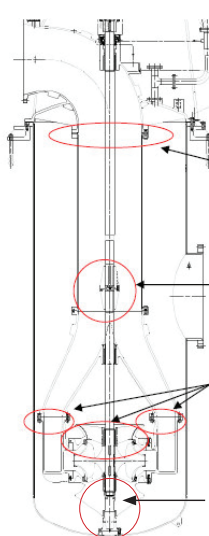
New Pump Design

Galvanic isolation of Zeron rising main and Ni-Resist discharge bend

Modified flanged coupling

Separation of trouserleg and suction bellmouth from bowl

Galvanic isolation of snubber from suction bellmouth

As ClydeUnion Pumps developed a new 3 piece casting for the pump casing, it now opens the opportunity to supply the customer with an individual section of the casing as required, instead of replacing the entire unit.
