CASE STUDY

NEW 3D MODELLING AND MANUFACTURING TECHNIQUES CUT PUMP COMPONENT LEAD TIMES BY UP TO 50%

A customer in the Middle East asked Clyde Union Pumps, a Celeros Flow Technology company, to provide a rapid response re-engineering service on a range of components for three third party BB4 type boiler feed pumps at a conventional power station. These included shafts and pressure boundary components.

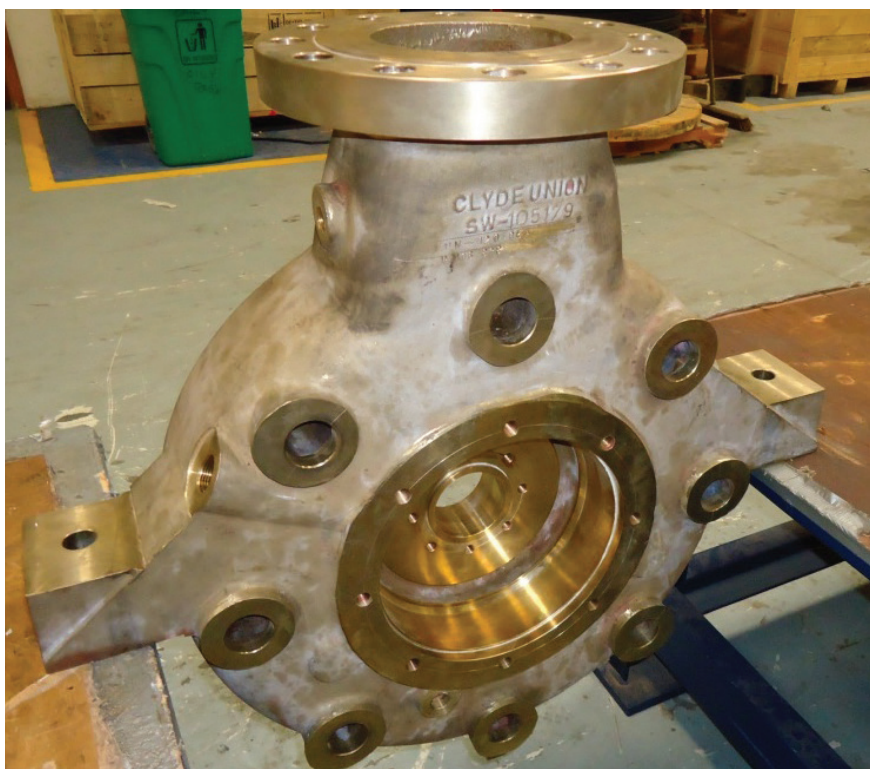
ClydeUnion Pumps re-engineered discharge cover

CAD software was used to convert the mesh files into full manufacturing models. Each component was then reviewed, with any design improvements incorporated into the models and new manufacturing drawings produced. Engineering reports, evaluation of component condition, operating history and required improvements were produced, together with quality plans, for approval by the customer.

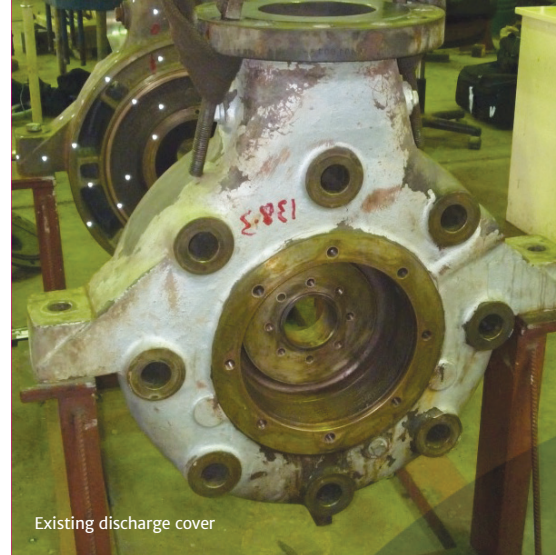
Existing discharge cover

To reduce downtime, one of the pumps was stripped at site and the components were visually and dimensionally inspected by a ClydeUnion Pump expert. The pump was then scanned using a state-of-the-art portable 3D laser scanner to produce a mesh STL surface in real time.

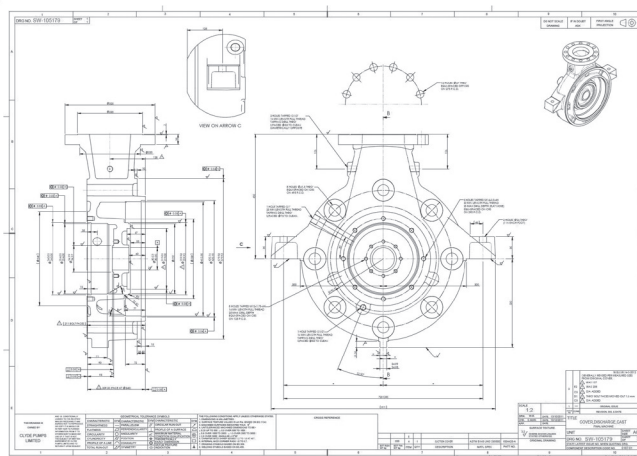
Drawings produced from model

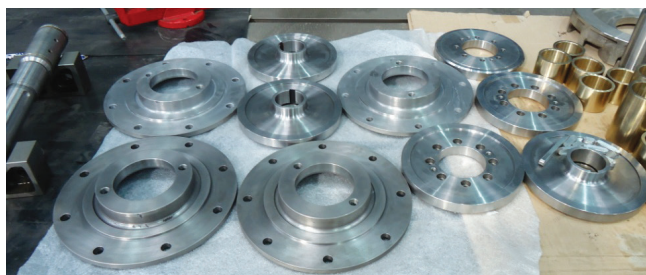
Supplied shaft and miscellaneous turned parts
