### Design modification LH 1050 for rotor interchangeability

<b>Industry:</b>	Oil + Gas - petrochemical
<b>Region:</b>	Europe
<b>Territory:</b>	France
<b>Category:</b>	Design upgrade
<b>API Type:</b>	BB1

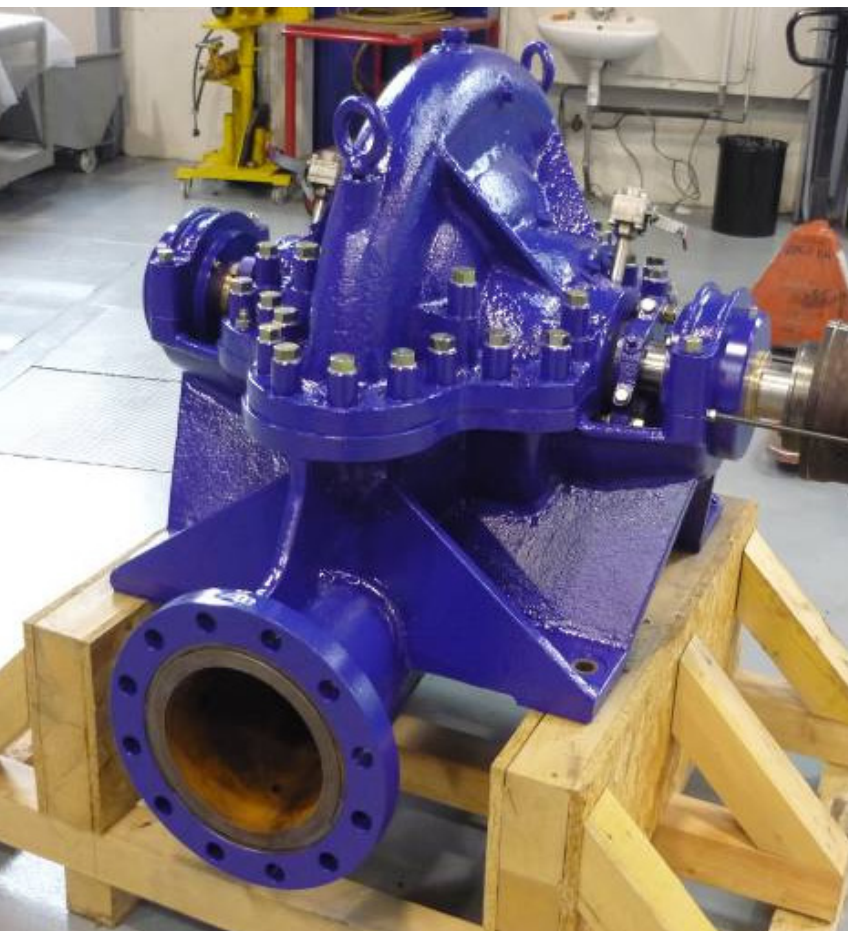
*Image left: Complete pump*

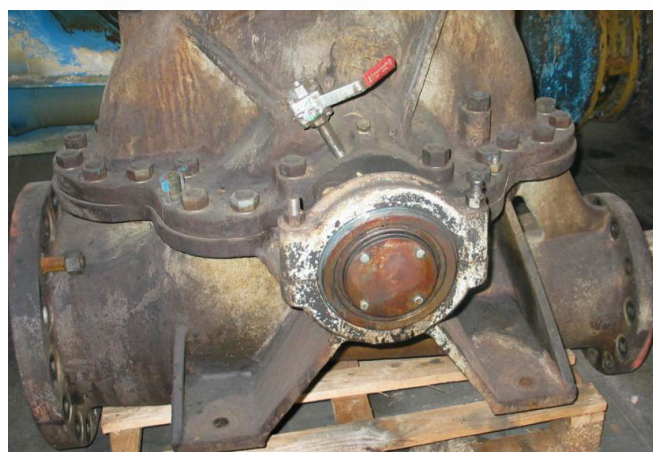
To guarantee complete interchangeability of the rotors, major design modifications had to be carried out on the bearing housings. The main causes of the non interchangeability were the differences in shaft and ball bearings diameter. Another issue was to keep the sealing system of the unused LH, two sealing braids and CMS 2000 between the braids (CMS 2000 is a fibre reinforced sealant).

*LH 1050.100 pump unused by the customer*

The other challenge faced was the clearances between the impeller trimmed at the diameter that corresponds with the characteristics for steam cracking process and the pump casing of the unused LH pump. Indeed, the volute of the unused pump was tighter than on the other pumps.

The solution was to completely redesign the bearing housings with an improvement of the sealing with the use of Inpro Seals instead of lip gaskets. The pump casing also had to be machined to suit the sealing components (CMS 2000 + braids) and to match the design clearances with the impeller.

- Re-design of bearing housings with standardisation of ball bearings size and improvement of sealing by use of Inpro Seals
- Machining of pump casing to increase the bore diameter for installation of the sealing system composed of braids and CMS 2000
- Machining of the volute to match design clearances between pump casing and maximum diameter of the impeller
