CUP-BB1 pump package rapid response solution

| API Type: | BB1 |

Ref no: CS-BB1-P-OG-01 Rev no: 002 UK

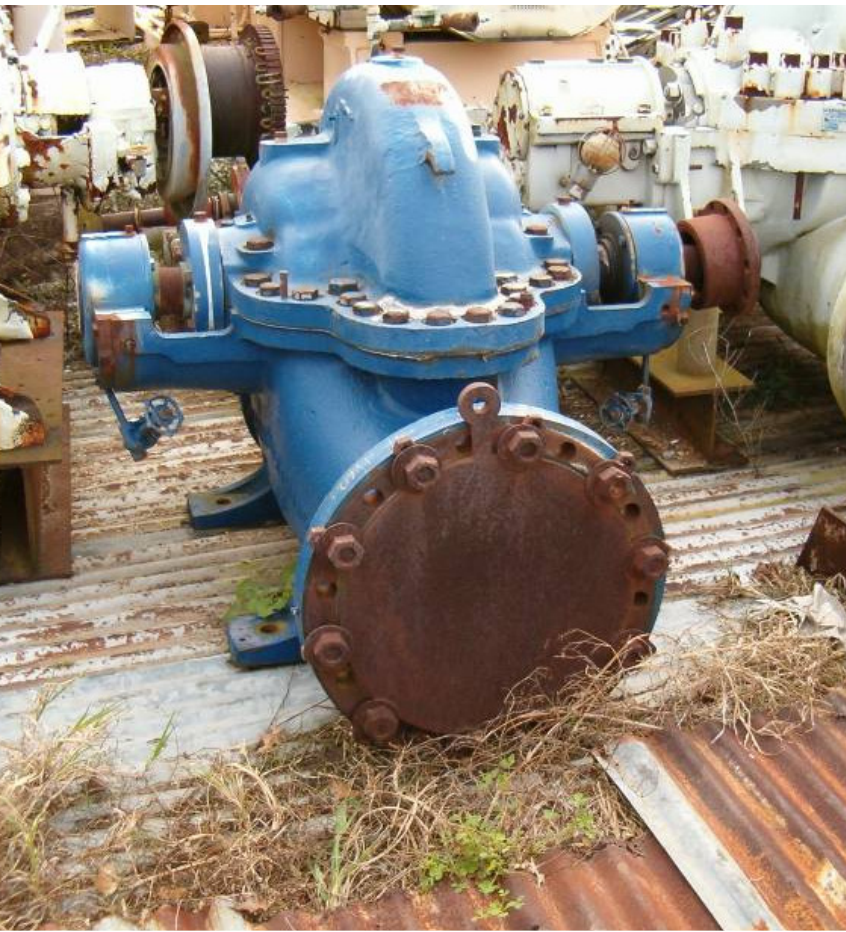
Image left: Worthington 10LN pump

Due to the short lead time available to meet the customer's request, a new complete pump offering could not be considered for this application. Therefore, a refurbished Worthington 10LN pump was purchased from a surplus pump vendor (above image), along with a refurbished 500 HP 6600 volt Westinghouse motor.

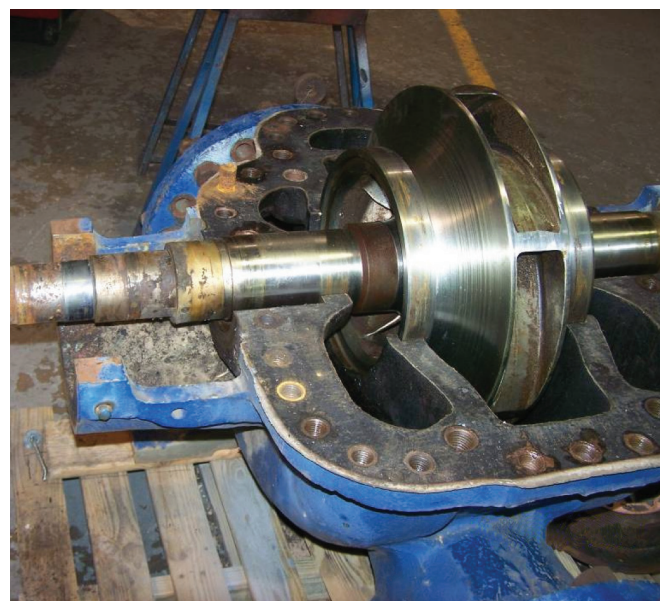
Figure 2: As found surplus pump

This project presented a number of difficult challenges due to the lead time and customer requirements. First, the bare shaft pump was dimensionally inspected at our service centre (Figure 2), overhauled by the service centre and sent for performance testing

to verify the hydraulic performance, vibration and noise levels. This was completed at our test facility in Battle Creek, Michigan.

A list of recommended spare parts were re-engineered and assigned part numbers.

Aftermarket engineering also designed an API 610 construction baseplate for the refurbished pump and motor taking into consideration the customers existing pump dimensions and limitations on available foundation.

The refurbished 500 HP motor was rebuilt with new bearings. All mechanical fits and tolerances were checked and brought back to proper specification. Performance testing of the motor was witnessed by aftermarket engineering. Mechanical seals were specified and installed.

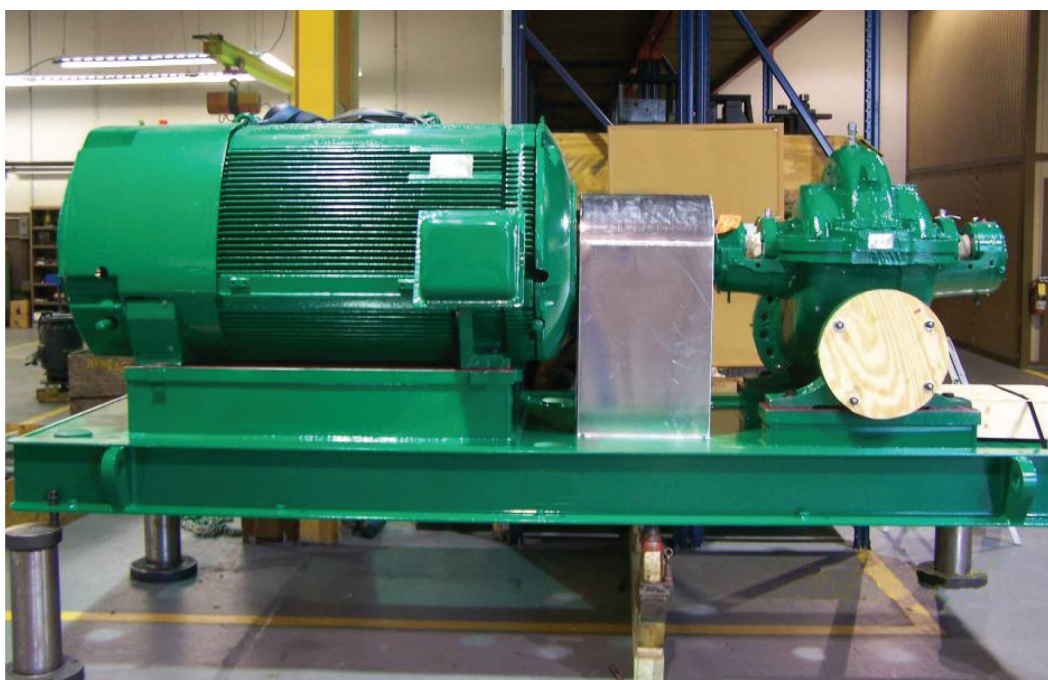
Figure 3: Completed unit

A ClydeUnion Pumps serial number was assigned to the pump and a bill of material was created for the recommended spare parts which will allow for ClydeUnion Pumps to take ownership of the pump and provide future spare parts. The complete unit (Figure 3) was delivered on time and to customer specification.
