Ingersoll-Rand JVL - mechanical upgrade

Industry: Industrial - paper mill
Region: Americas
Territory: USA
Category: Mechanical design upgrade
API Type: BB2

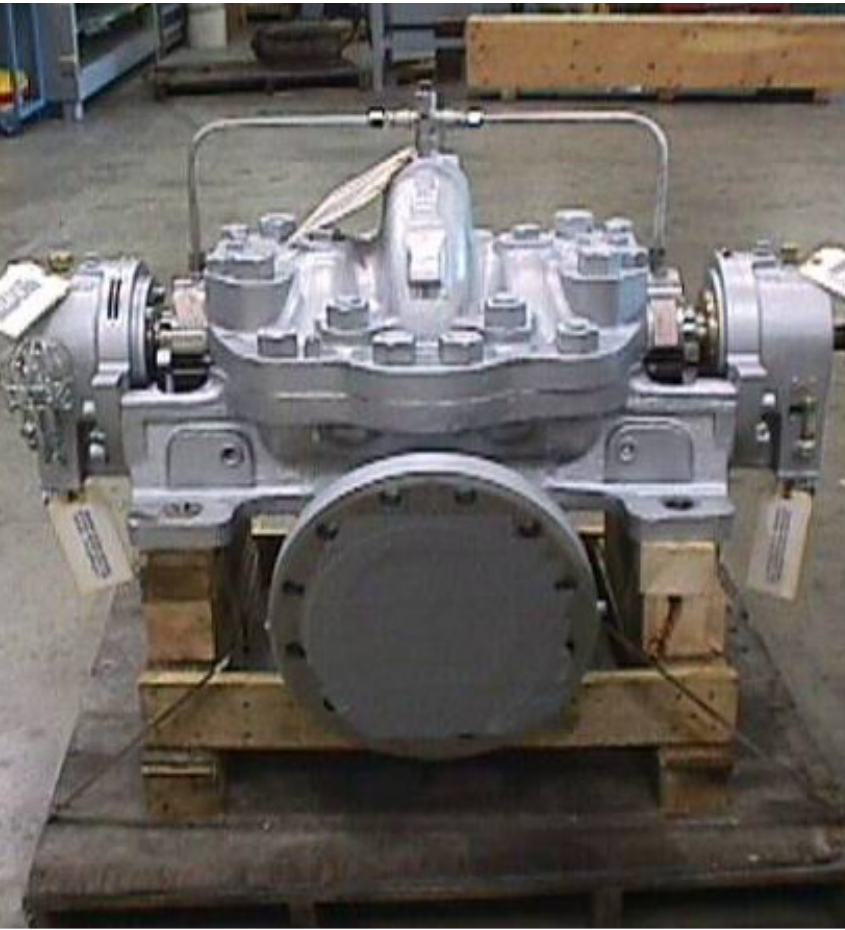
Image left: Complete pump

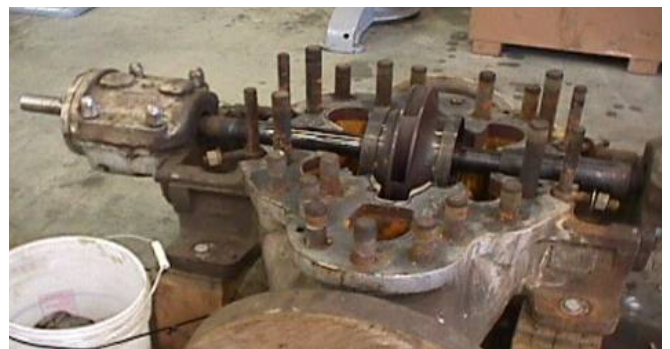
The project included a mechanical upgrade on an Ingersoll-Rand 8 JVL to extend the reliability and Mean Time Between Repairs (MTBR). The shaft was found sheared under the impeller fit, as indicated by rotation of continuous key by 30°. The impeller was found with a crack in the hub of the impeller at the keyway and the impeller wear rings were also rubbing 360° around. Some case damage was found from erosion and rubbing of the impeller.

Top half of casing removed to see condition of the rotor.

The new design was based on increasing the margin between the first natural frequency and the running speed. This was achieved by changing the shaft diameter, the distance between bearings, and the distance from the radial bearing and coupling. The throat bushing was also upgraded to graphalloy and installed with mechanical seals. With these changes, we were able the increase margins considerably (see table 2).
