## Abrasive process upgrade for DVMX 10 stage pumps

<b>Industry:</b>	Industrial - steel
<b>Region:</b>	Europe
<b>Territory:</b>	France
<b>Category:</b>	Service centre overhaul
<b>API Type:</b>	BB3

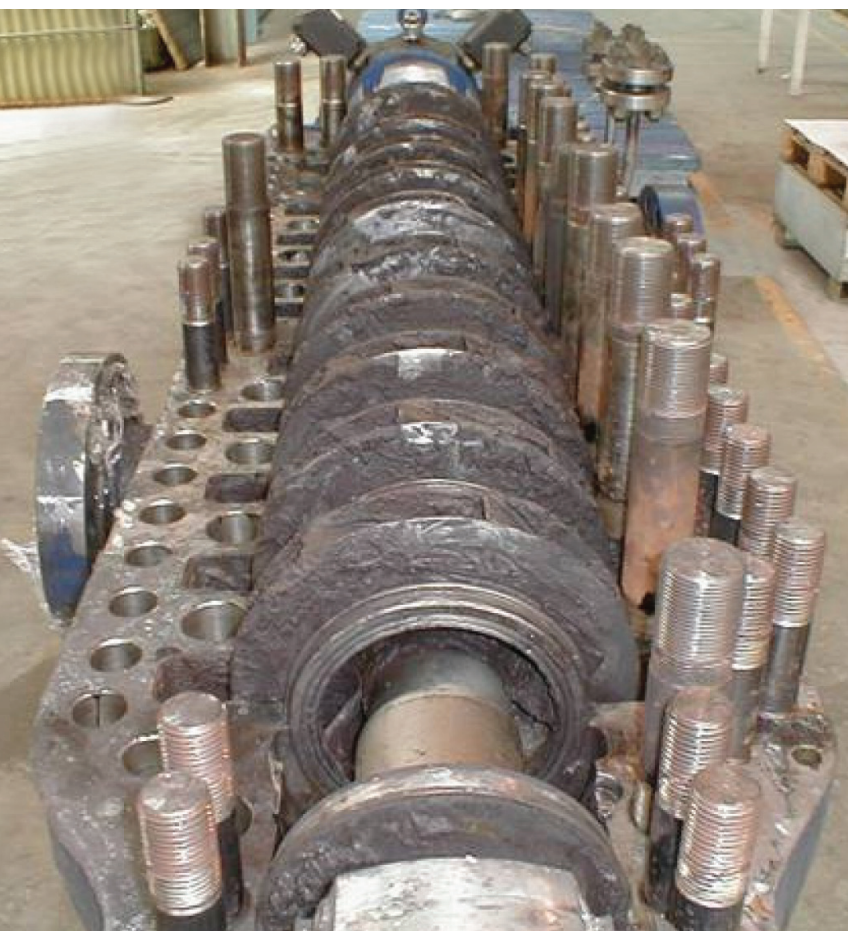
*Image left: Erosion/scaling of pump parts*

The function of the pumps is to water blast the scale off processed metal passing through the rolling mill. The water, containing the pulverised scale, goes to retention and decantation pools, then passes through a system of filters before being reused to blast the processed metal. Despite the system of filters, the water containing small particles of scale that is re-pumped was causing considerable damage to the inside of the DVMX pumps.

- Strip down and full dimensional inspection of parts
- Refurbishment of parts by weld deposition where possible
- Reconditioning of threaded holes
- Heat treatment and re-machining of weld repaired parts including gasket faces
- Re-boring for shaft concentricity and re-machining of gasket faces where necessary
- Cleaning of pipes and channels
- Re-assemble and hydrostatic test
- Clean down and paint

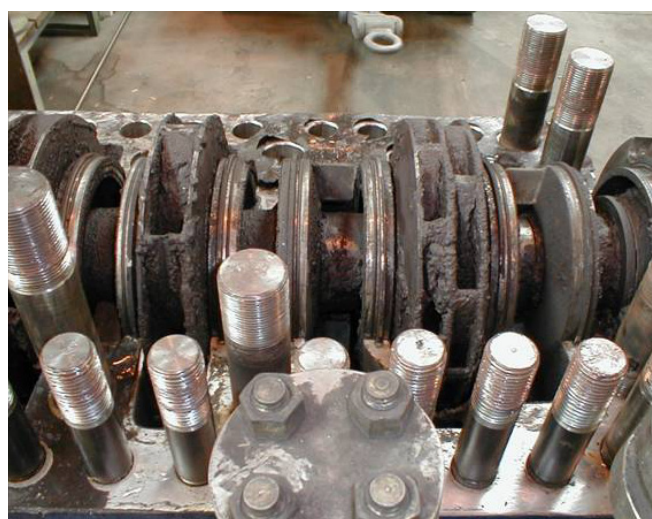
*Erosion/scaling of pump parts*

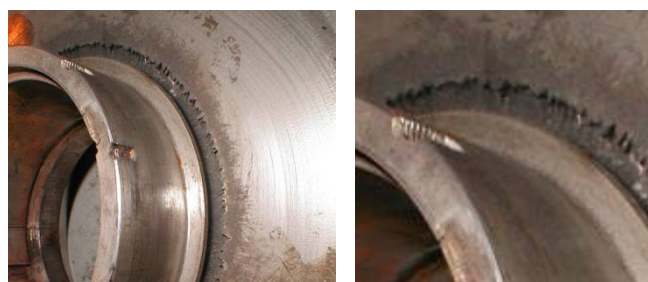
- Modifications included changes to clearances, redesign of parts and additional gaskets. The purpose of these modifications was to decrease erosion on some sensitive areas of the pumps (gasket face) and channel it to the wear parts.
- Hard tungsten-chromium carbide coatings on central bearing bush, sleeve, piston and wear rings.
- Hard tungsten carbide coatings on impellers 5 and 10 (on each side of central bearing). When the water containing small particles of scale passes between wear rings, it causes damage to the back shrouds of these impellers.

Damage to the back shrouds of impellers
