Pacific 4" AC barrel pump

Industry:	Oil + Gas - downstream oil
Region:	Americas
Territory:	USA
Category:	Re-engineering
API Type:	BB5

To provide re-engineering on impellers and diffusers for a complete overhaul and upgrade for a Pacific 4" AC 4 stage.

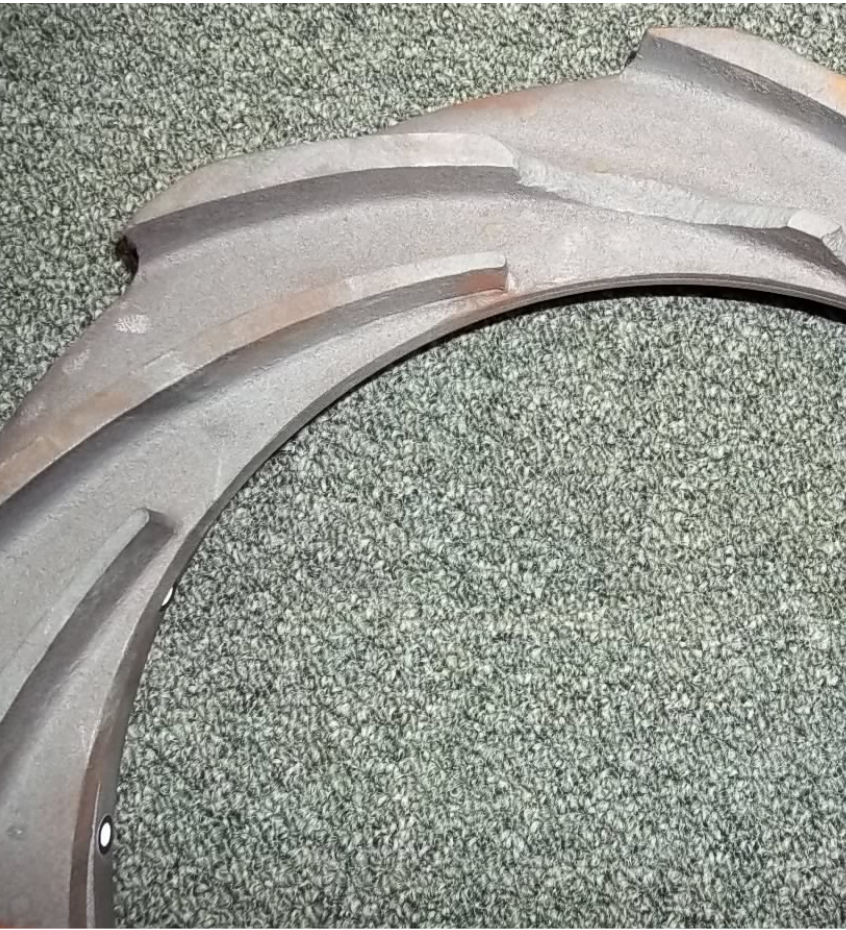
Image left: Damaged diffusers

The request by the customer was to repair existing impellers and fabricate new diffusers for limited down time.

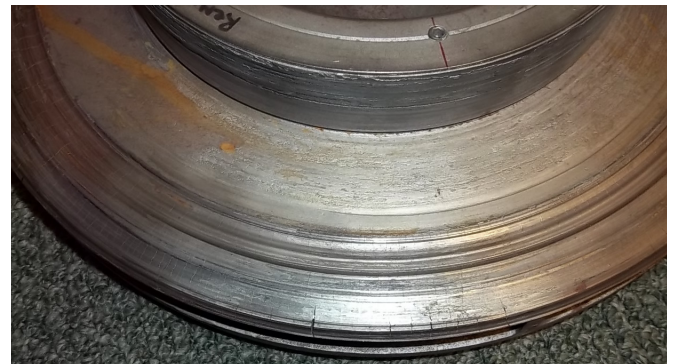
Damaged impeller

- The impellers have a shrink fit to the shaft
- The spacer sleeves were removed and replaced with shaft sleeves (with a interference fit to the shaft) against which the stationary bushings run

- The impellers and shaft sleeves were individually located on the shaft using split locating rings. The locating rings fit into a groove in the shaft and the impeller or sleeve slide over the ring to hold it into the groove

- As the pieces are individually located the chance of bowing the shaft or having excessive runouts is greatly reduced because the added affect of stacking the parts together is eliminated. It also increases the ability of repeating the runouts and balance of the rotor

- In the new shaft stepped design, each impeller fit is slightly smaller than the previous, this makes assembly and disassembly of the rotor easier
- The balance piston is held up against the shaft shoulder using a split locating ring. A nut threads onto the shaft and goes over the split ring to hold it in place. This reduces the chance of the balance piston coming loose or causing a bow in the shaft

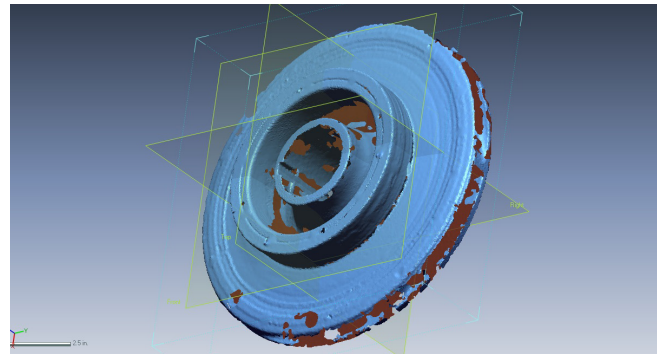
3D scan of damaged impeller

Utilising state-of-the-art, non-contact, laser base hardware and software technology, we provided a highly accurate scan data so that we are able to supply the customer with spare parts in the future.

Once the part is scanned and inspected, the file is electronically transmitted along with the engineer report describing the condition of the part and any operational history and improvement requirements discussed with the operator. If required, a full laboratory metallurgical failure mode analysis report can be arranged at this stage to better understand complex reliability problems. After analysis and review by the ClydeUnion Pumps design and improvement engineers, scanned data is then used to create a full manufacturing model and drawing of the part.

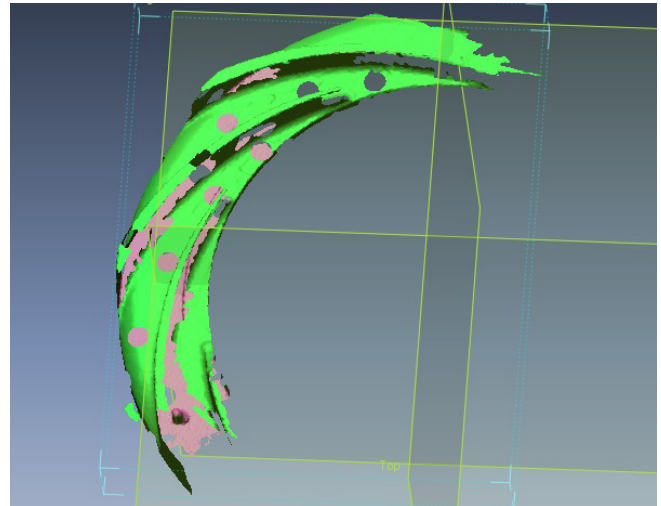
3D scan of damaged diffuser
