## VM32 upgrade - discharge elbow + bearing modifications

**Category:** Site fault investigation

**API Type:** VS6

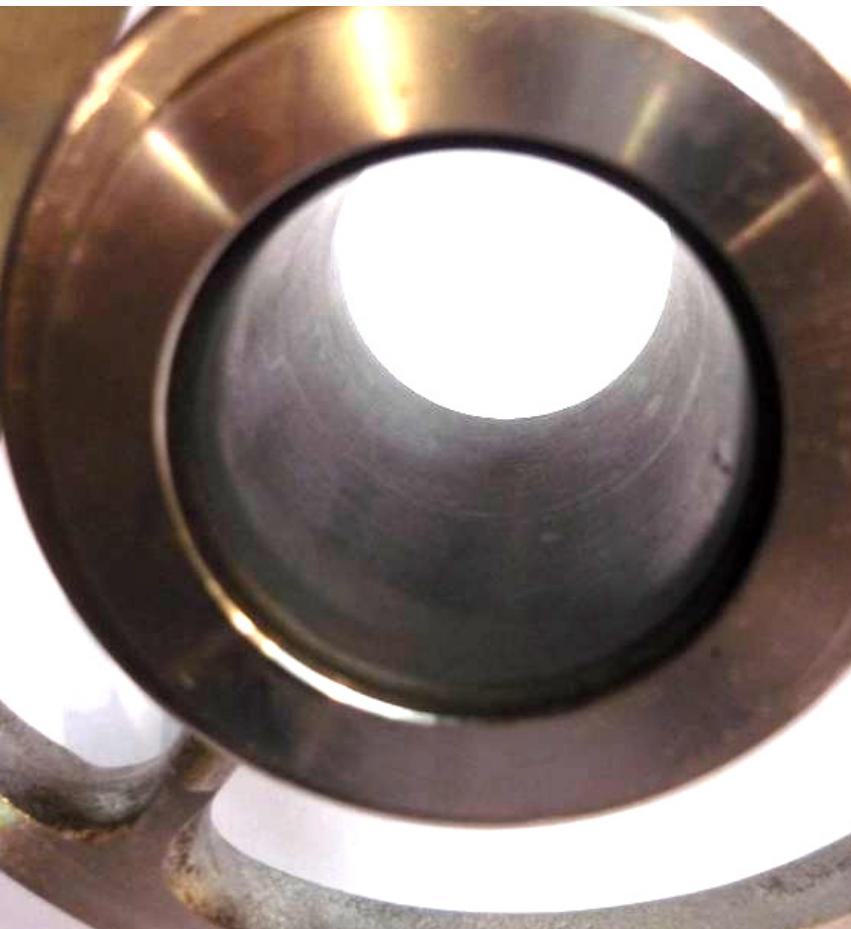
*Image left: Vespel® bearing*

Due to the abrasive nature of the liquid pumped (water + organic matter), the choice was made to change the former PTFE based bearings to Vespel® CR6100 bearings.

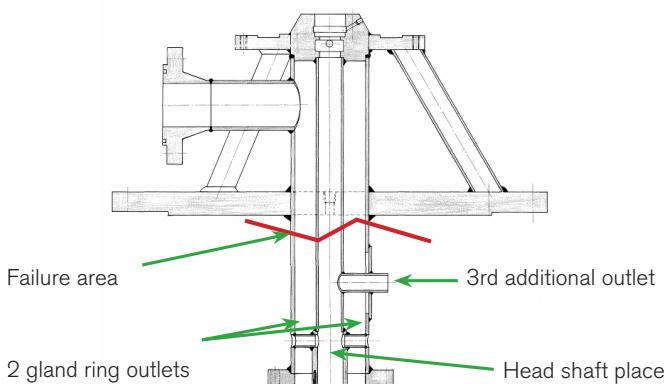
Our customer had previously independently repaired the discharge headpiece pipe on a vertical chemical pump as it had cracked several times. Due to the complexity and difficult accessibility of the welding, plus relative fragility of the assembly, the consultation between ClydeUnion Pumps and the customer resulted in agreement to re-design the whole discharge elbow.

The gland ring outlets on the discharge elbow were not sufficient to evacuate the liquid that passes around the head shaft. To solve this problem a third outlet had been added to the discharge elbow, but this modification has weakened the lower part of the discharge elbow. This weakness leads to a crack of the discharge elbow.

The solution was to re-design the discharge elbow and separate it in two parts, the elbow itself, above the support surface, and a suction spool under. ClydeUnion Pumps also made the decision to change the former bearings material to a Vespel® CR6100 (carbon fibers in PTFE resin matrix). Indeed the corrosive nature of the liquid pumped increases the hydraulic clearances of the pump. These gaps generated vibrations that contribute to the destruction of the discharge elbow. The choice of Vespel® CR6100 was done for its excellent resistance at wear and abrasion and chemical compatibility.

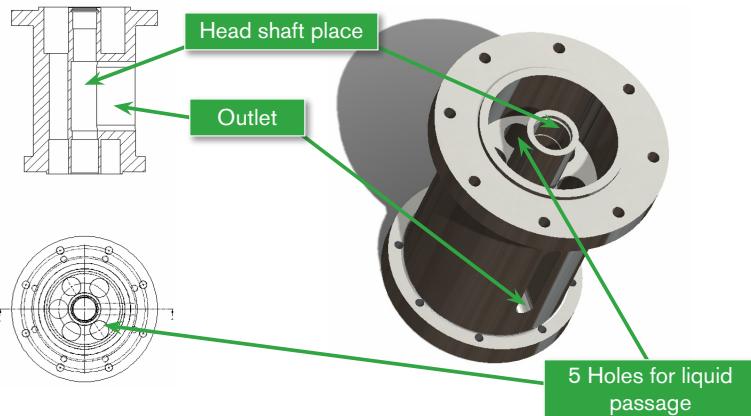
- Re-design of the upper part of the discharge elbow**

This part is designed to be stiffer than the older version. It also integrates a salvage pipe for possible leaks.

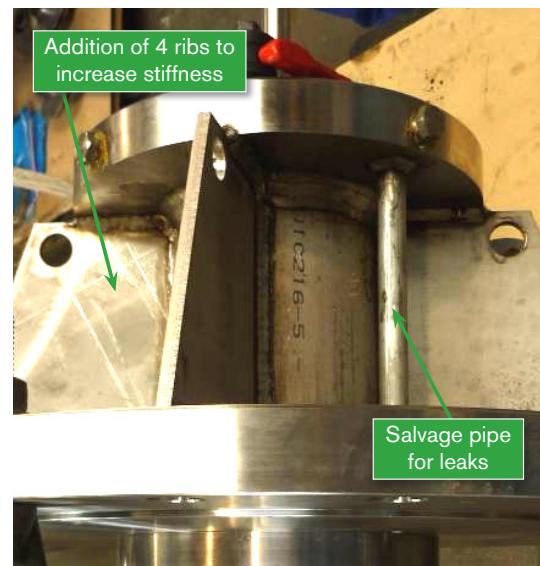
- Re-design of the lower part of the discharge elbow (suction spool)**

The preferred design was made to have a single piece part to increase its solidity. The former 3 gland ring outlets are replaced by one, and the liquid pumped passed by 5 holes that represent an area equivalent to the former version.
