Design modification LH 1050 for rotor interchangeability

Industry: Oil + Gas - petrochemical
Region: Europe
Territory: France
Category: Design upgrade
API Type: BB1

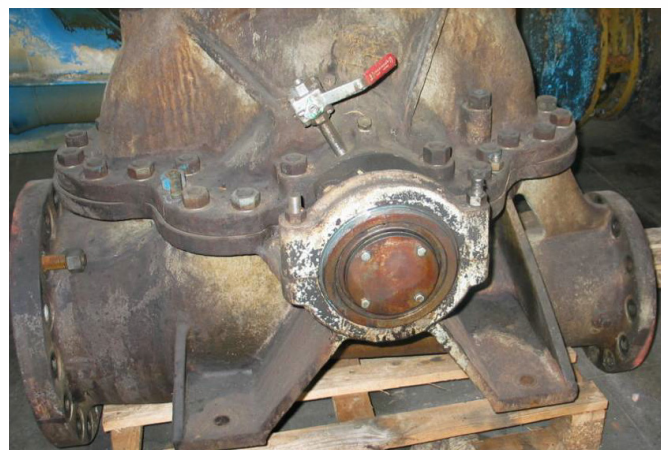
To guarantee complete interchangeability of the rotors, major design modifications had to be carried out on the bearing housings. The main causes of the non interchangeability were the differences in shaft and ball bearings diameter. Another issue was to keep the sealing system of the unused LH, two sealing braids and CMS 2000 between the braids (CMS 2000 is a fibre reinforced sealant).

LH 1050.100 pump unused by the customer

The other challenge faced was the clearances between the impeller trimmed at the diameter that corresponds with the characteristics for steam cracking process and the pump casing of the unused LH pump. Indeed, the volute of the unused pump was tighter than on the other pumps.

The solution was to completely redesign the bearing housings with an improvement of the sealing with the use of Inpro Seals instead of lip gaskets. The pump casing also had to be machined to suit the sealing components (CMS 2000 + braids) and to match the design clearances with the impeller.

- Re-design of bearing housings with standardisation of ball bearings size and improvement of sealing by use of Inpro Seals
- Machining of pump casing to increase the bore diameter for installation of the sealing system composed of braids and CMS 2000
- Machining of the volute to match design clearances between pump casing and maximum diameter of the impeller
