Bingham 4 x 6 x 10B MSD hydraulic re-rate

Industry: Oil + Gas - upstream oil
Region: Americas
Territory: USA
Category: Hydraulic re-rate
API Type: BB3

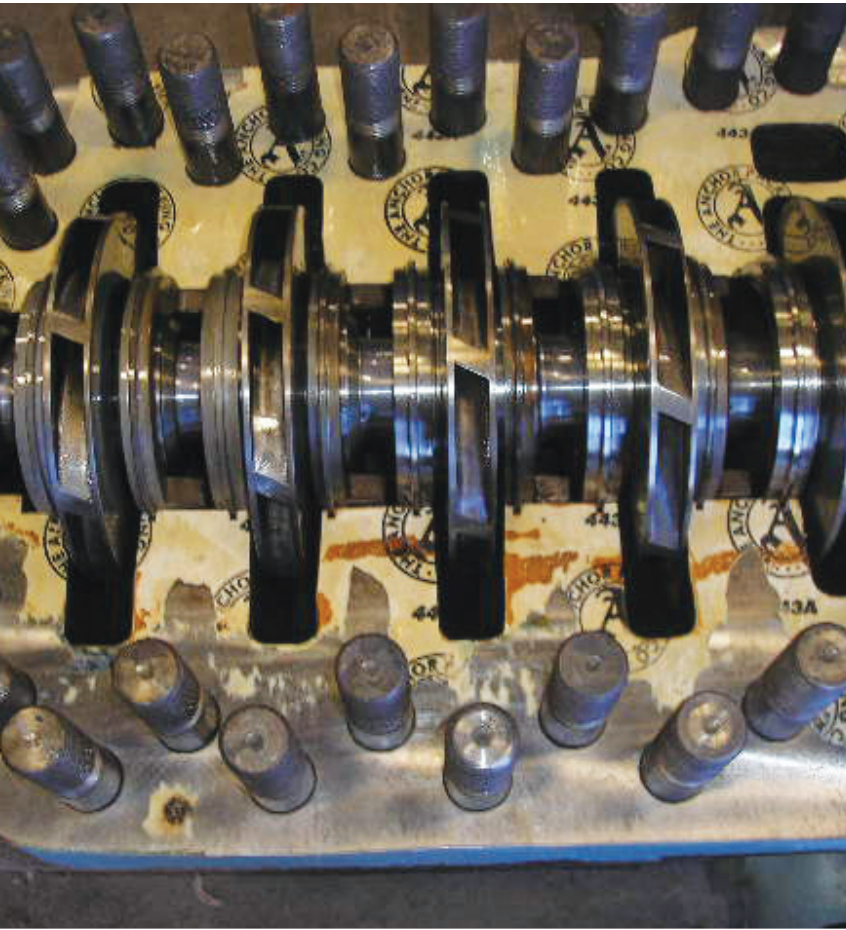
Image left: Bingham 4 x 6 x 10B MSD

This project included a hydraulic re-rate on a Bingham 4x6x10B MSD to new hydraulic conditions whilst maximising efficiency. The customer requested a cost savings analysis to justify the payback for the proposed re-rate.

Initial values were taken for pressure, flow and power prior to the pump being pulled from the field and assessed for possible modification options. It was determined the customer had been throttling back the pump discharge for a number of years and thus wasting energy. Various options were considered, including de-staging the pump or possibly slowing the speed of the motor using a VFD. It was determined the most cost effective modification was to trim the impellers and restore running clearances back to API 610 standards.
