CASE STUDY

ENGINEERED SOLUTION SIGNIFICANTLY EXTENDS MTBF

CLYDEUNION®
PUMPS

Industry: Oil extraction
Region: Middle East
Category: Material upgrade
API Type: BB2

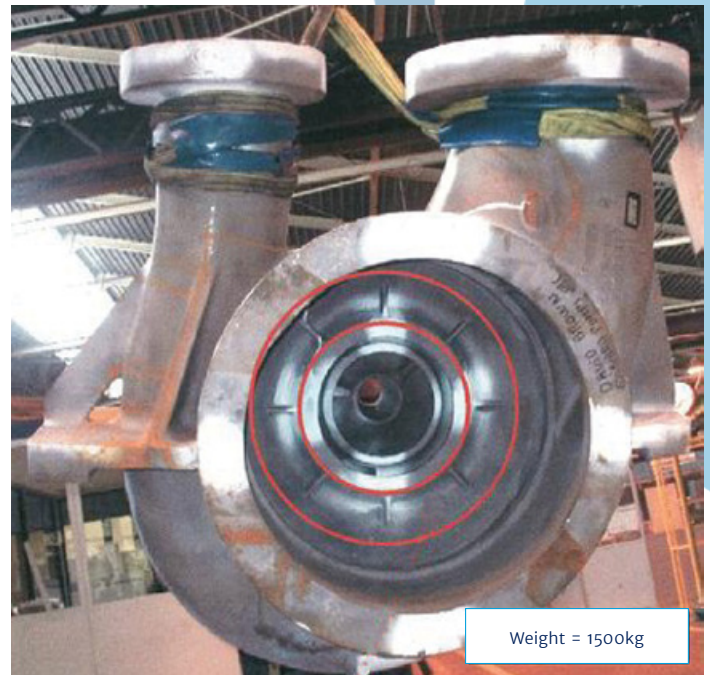
Weight = 1500kg

Casing cover with erosion resistant coating

Pump replacement was an expensive option, so we proposed a triple solution to upgrade the existing BB2 pump. Firstly, the damaged surfaces of the pump casing were weld repaired. Secondly, anti-vortex ribs were welded on the pump casing and cover to mitigate scouring. Finally, a tungsten carbide hard coating was applied to the inside surfaces of the pump and cover to protect them from further wear.

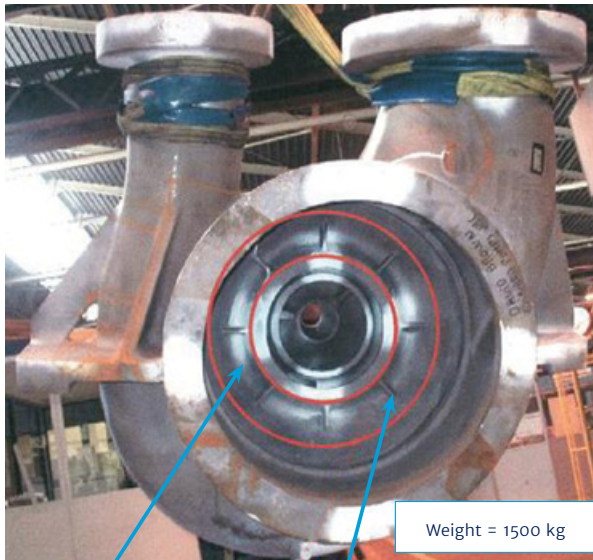
KSMK casing cover

Area for hard coating

8 anti-vortex ribs

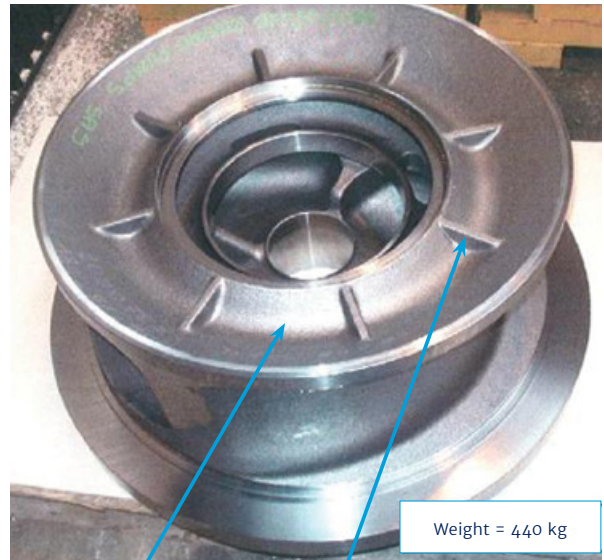
Area for hard coating

8 anti-vortex ribs
